SUBJ: EPA Asbestos Removal at 319 Sloan Street

REMOVAL ACTION STATUS REPORT DAVIDSON ASBESTOS

Property Address: 315 and 319 Sloan Street, Davidson, Mecklenburg County, North Carolina

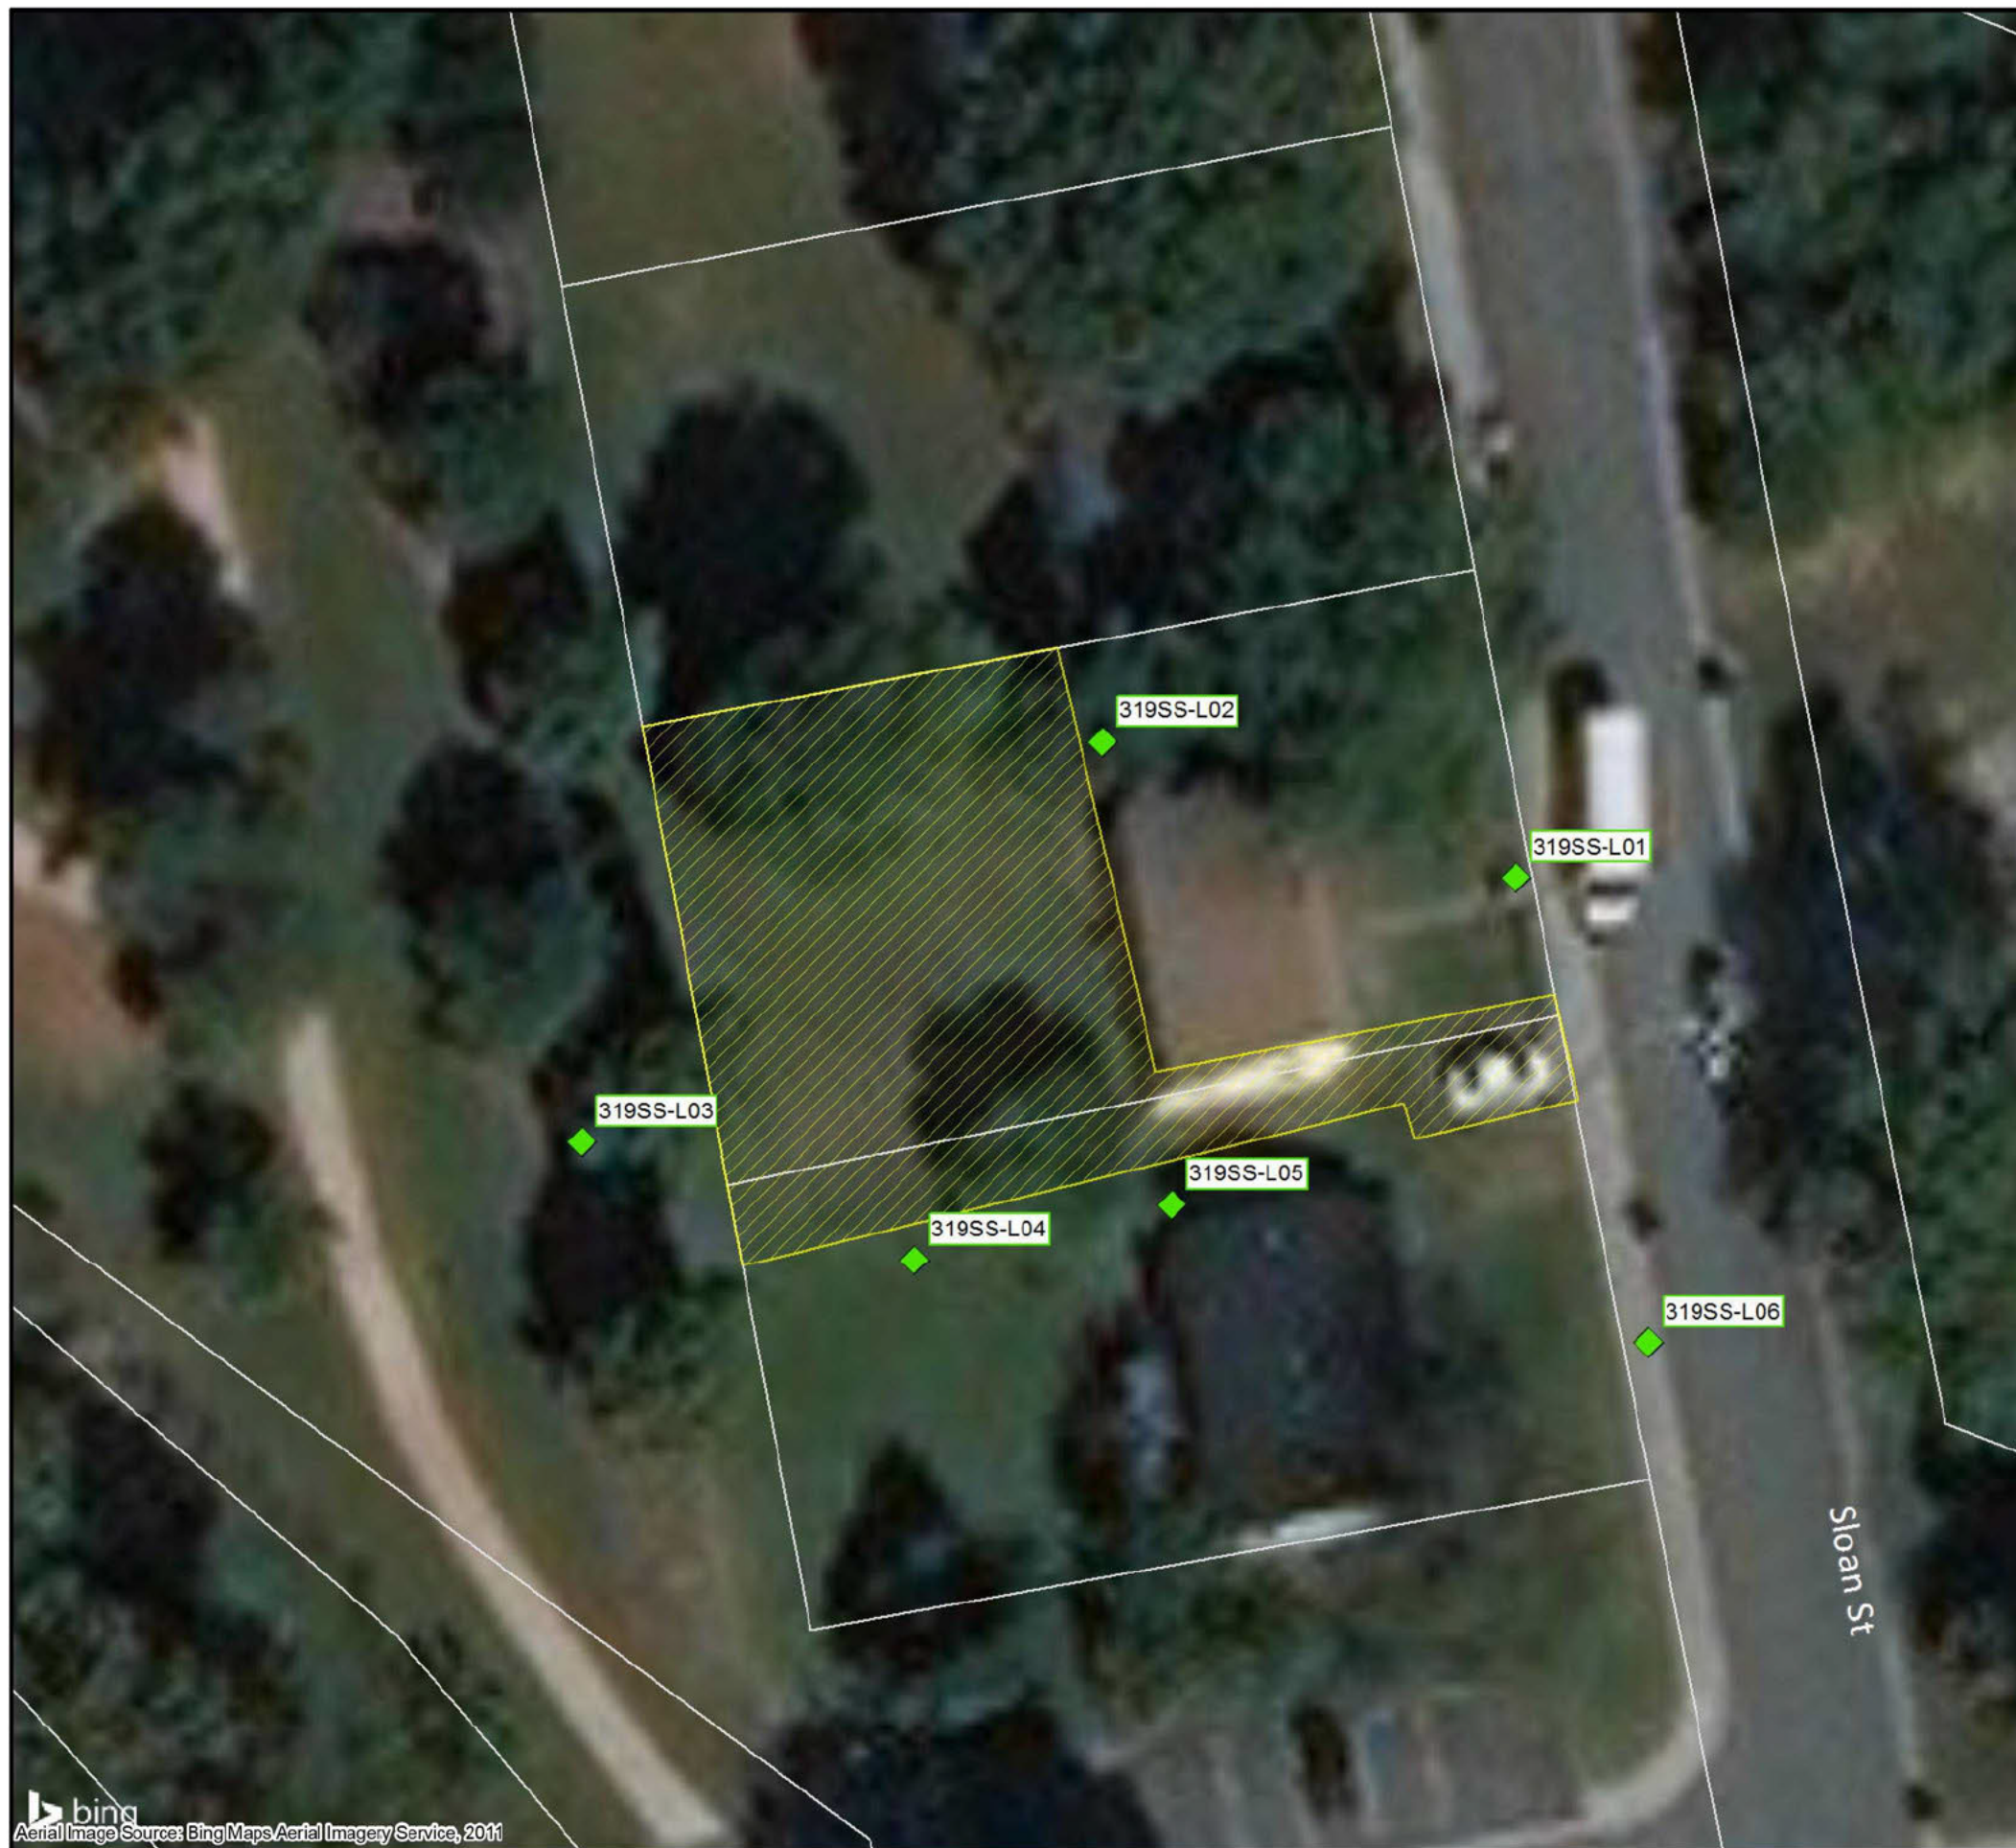
FIGURE 1

Description of Removal Action: The soil was excavated to an approximate maximum depth in the following areas: driveway of 315 Sloan Street to 24 inches; back yard and driveway of 319 Sloan Street to 12 inches; and, tree line and residential drip line areas of 319 Sloan Street to 3 inches (See Appendix 1). Visual inspections of the excavated areas for asbestos-containing materials (ACM) were conducted by a State of North Carolina-accredited asbestos inspector and air monitor. Additional removal was conducted in those areas where ACM were still visibly present. Once ACM was no longer visibly present at 319 Sloan Street, restoration of the areas excavated was allowed to commence. ACM was still visibly present in the driveway of 315 Sloan Street. The remaining ACM was photographed and documented in the site logbook before restoration began.

Removal Areas and
Air Sampling Locations

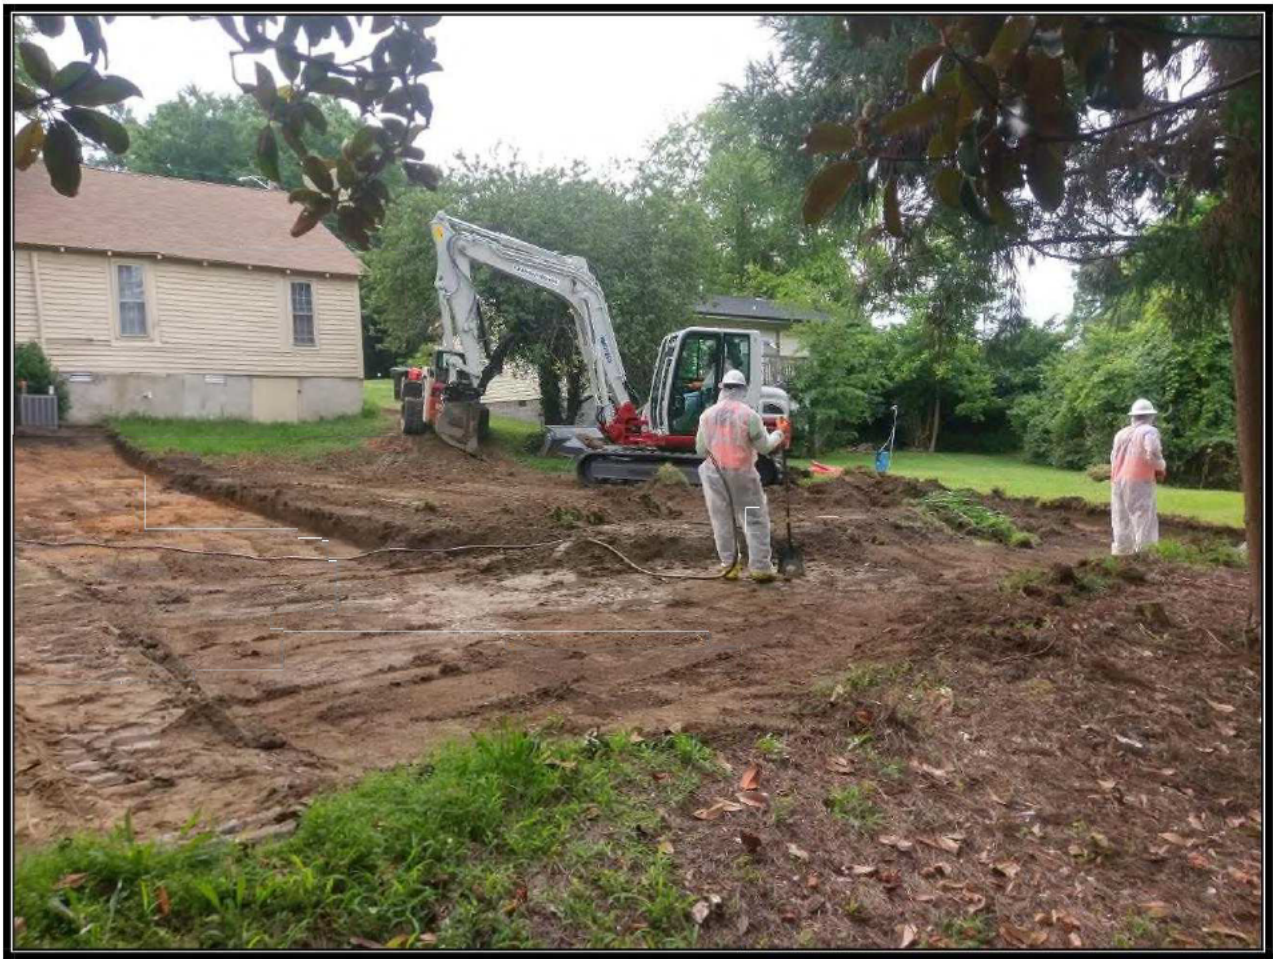
OFFICIAL PHOTOGRAPH NO. 1
U.S. ENVIRONMENTAL PROTECTION AGENCY

Subject: The Emergency and Rapid Response Services (ERRS) contractor, Environmental Restoration, LLC (ER), used an excavator and hand tools to remove asbestos-containing materials (ACM) and asbestos-contaminated soil from the property located at 319 Sloan Street. ER used hoses to wet the asbestos-contaminated soil and spread plastic sheeting under the dump trucks to prevent asbestos-contaminated soil from falling onto the sidewalk and the road during removal activities.

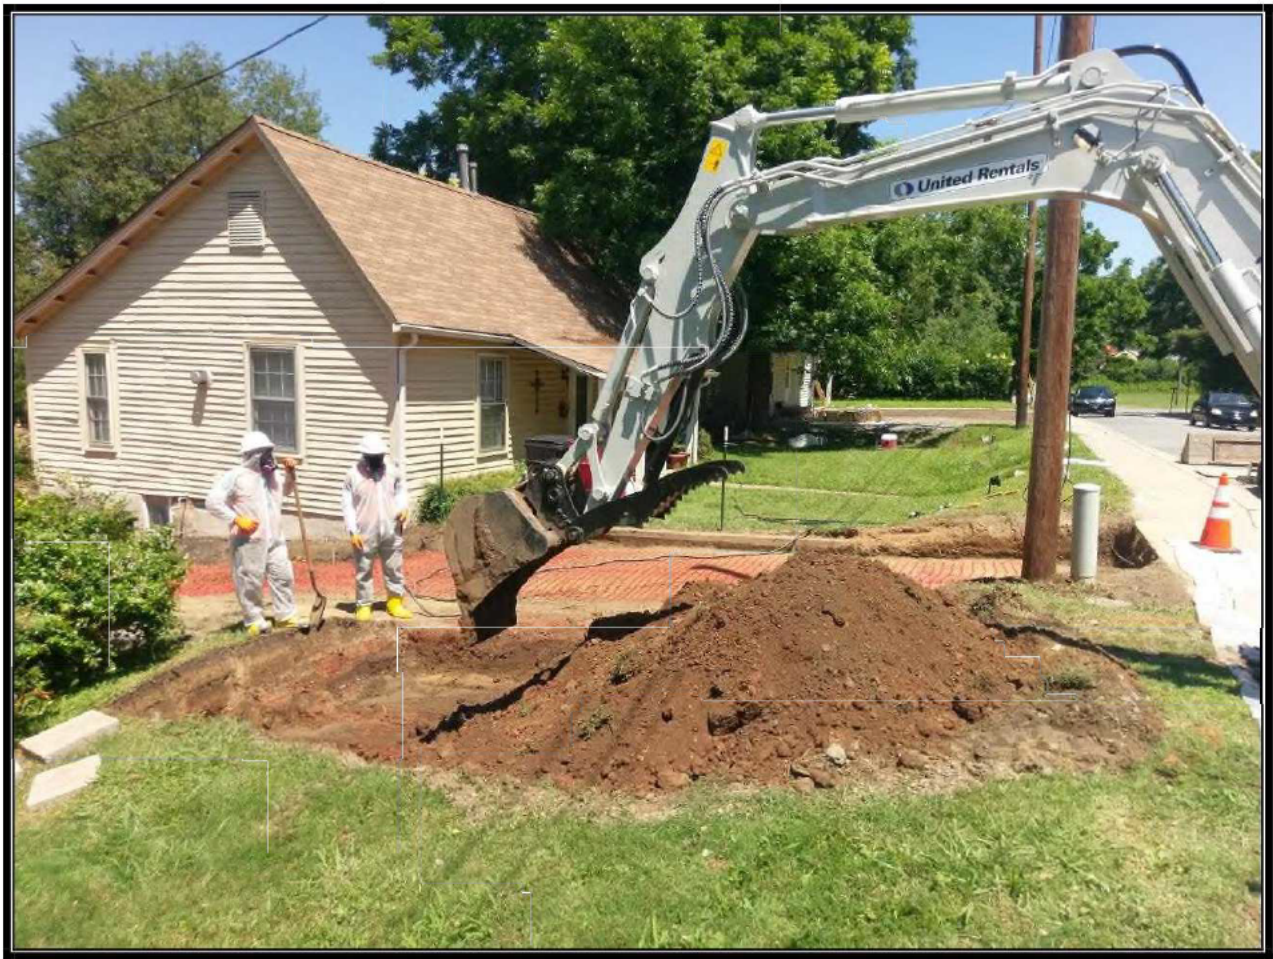
OFFICIAL PHOTOGRAPH NO. 2
U.S. ENVIRONMENTAL PROTECTION AGENCY

Subject: ER used an excavator and hand tools to remove ACM and asbestos-contaminated soil from the property located at 315 Sloan Street. ER used hoses to wet the asbestos-contaminated soil during removal activities.

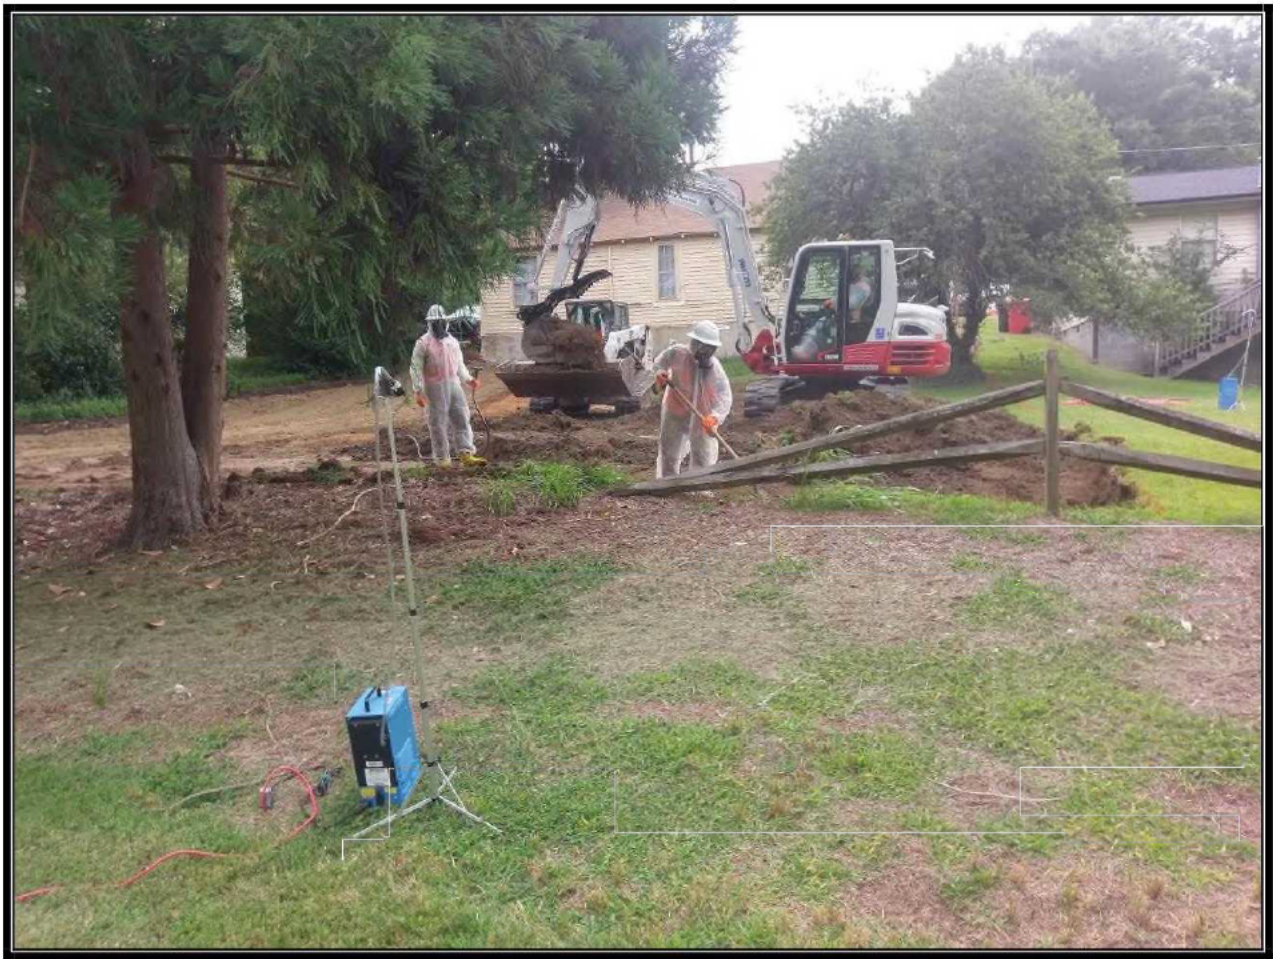
OFFICIAL PHOTOGRAPH NO. 3
U.S. ENVIRONMENTAL PROTECTION AGENCY

Subject: Perimeter air sampling was conducted by a Tetra Tech Superfund Technical Assessment and Response Team (START), State of North Carolina-accredited air monitor to evaluate the effectiveness of engineering and safety controls in preventing off-site migration of asbestos fibers during removal activities at 319 Sloan Street.

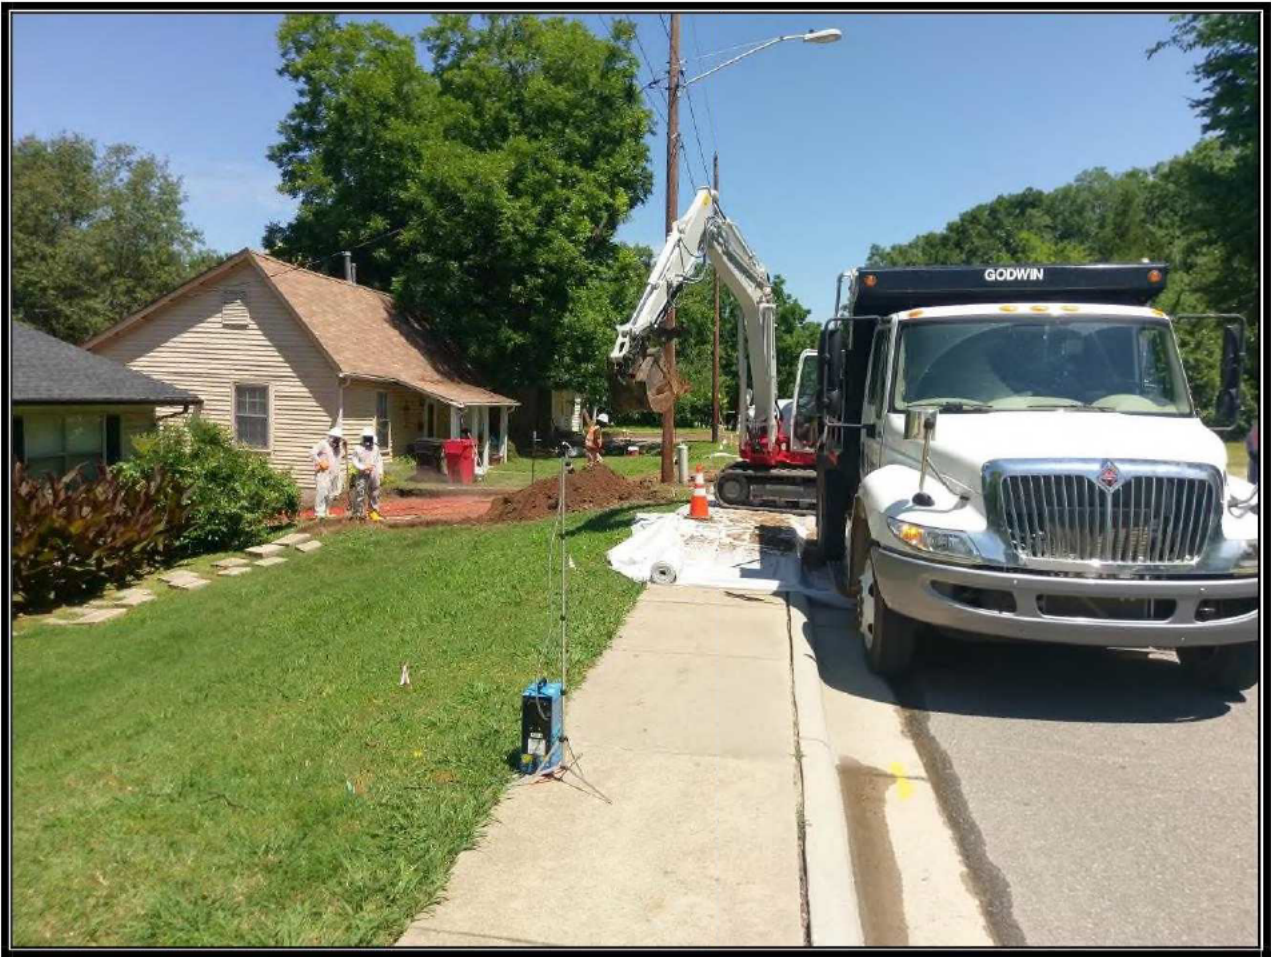
OFFICIAL PHOTOGRAPH NO. 4
U.S. ENVIRONMENTAL PROTECTION AGENCY

Subject: Perimeter air sampling was conducted by a Tetra Tech START, State of North Carolina-accredited air monitor to evaluate the effectiveness of engineering and safety controls in preventing off-site migration of asbestos fibers during removal activities at 315 and 319 Sloan Street.

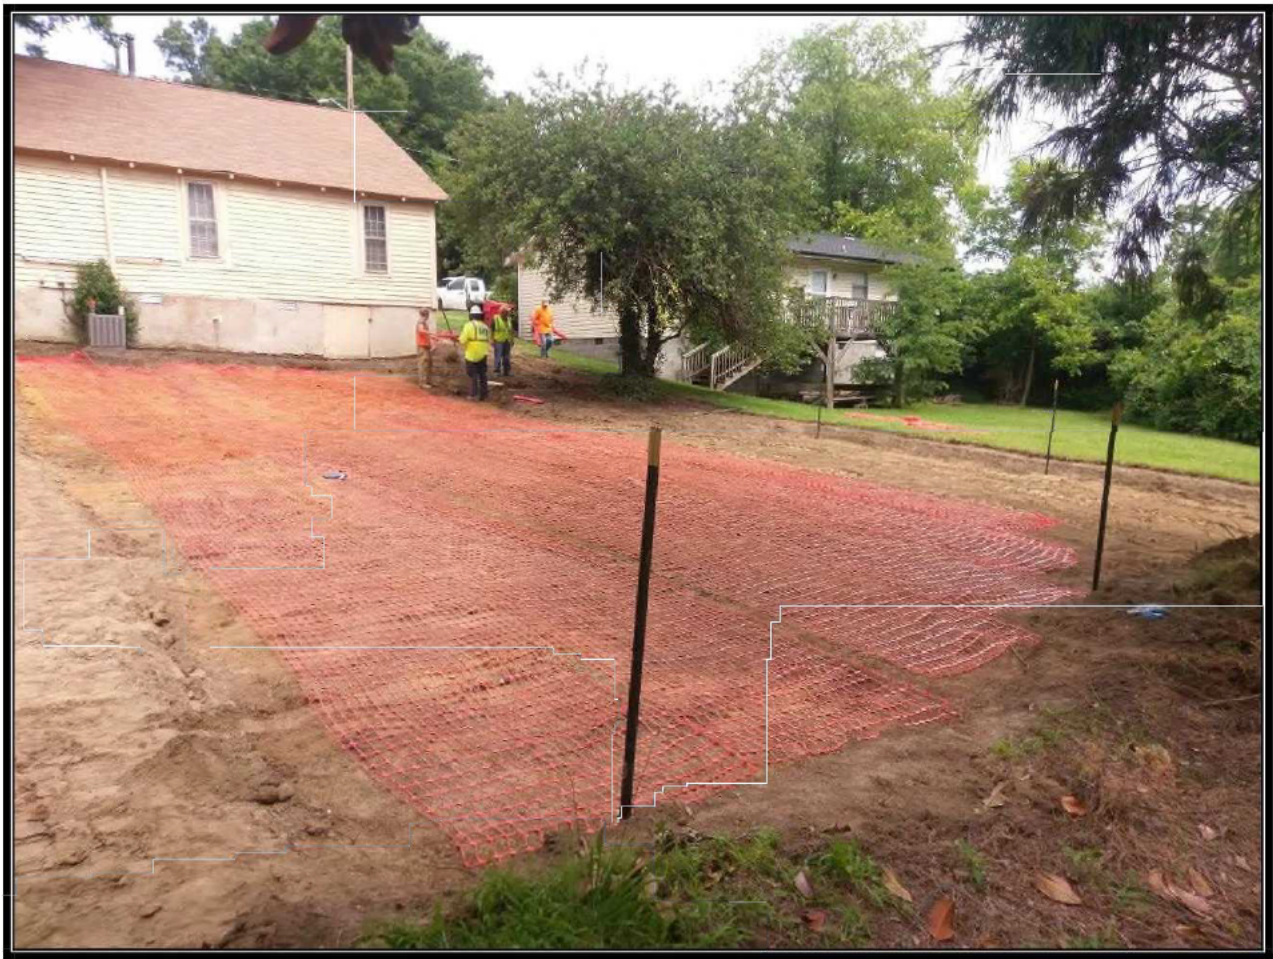
OFFICIAL PHOTOGRAPH NO. 5
U.S. ENVIRONMENTAL PROTECTION AGENCY

Subject: ER installed snow fencing along the subsurface of the excavated back yard of 319 Sloan Street after the visual inspection conducted by Tetra Tech START, State of North Carolina-accredited asbestos inspector and air monitor detected no visible ACM in the excavated area.

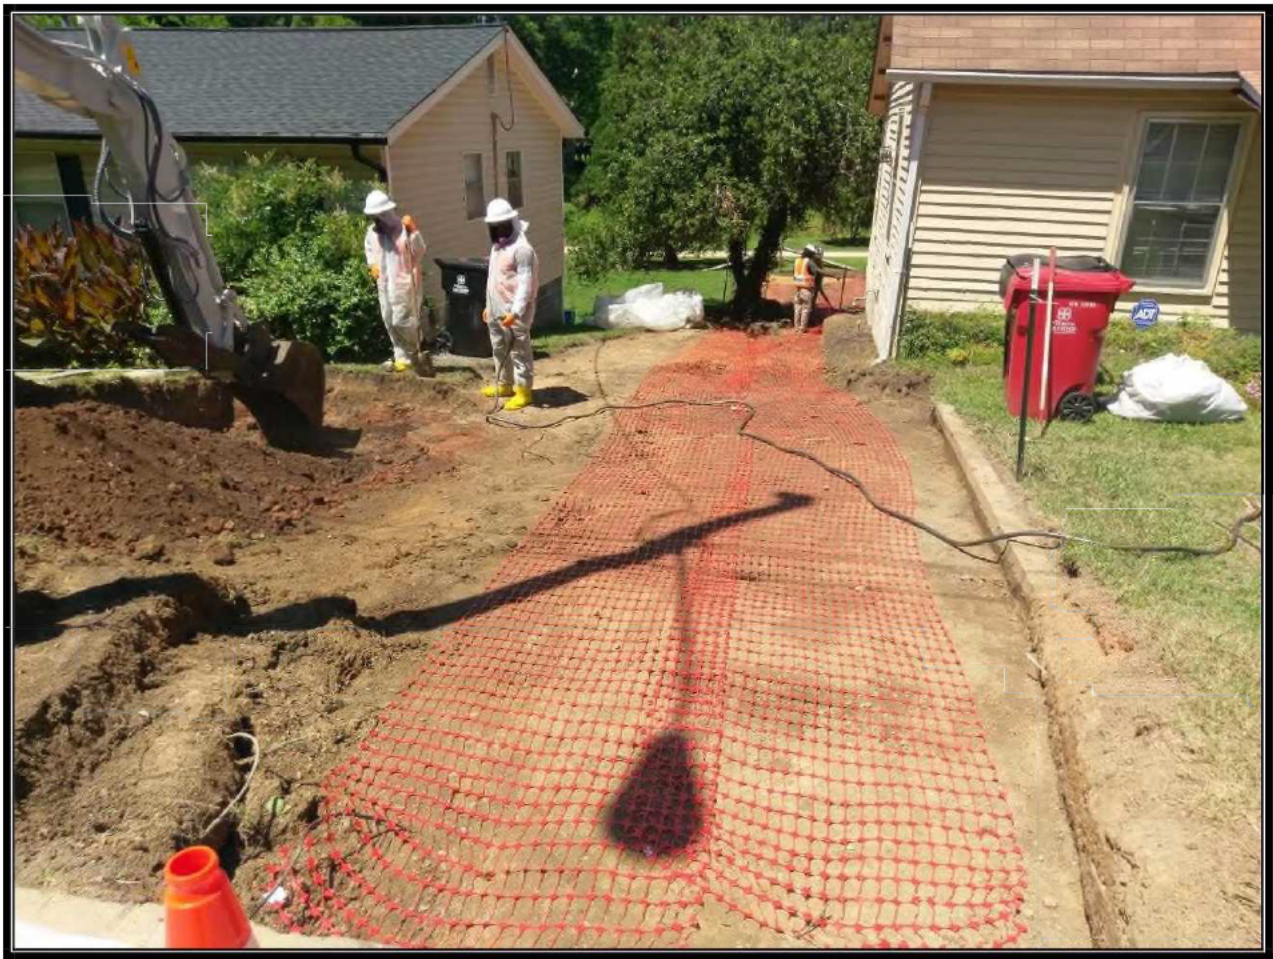
OFFICIAL PHOTOGRAPH NO. 6
U.S. ENVIRONMENTAL PROTECTION AGENCY

Subject: ER installed snow fencing along the subsurface of the excavated driveway of 319 Sloan Street after the visual inspection conducted by Tetra Tech START, State of North Carolina-accredited asbestos inspector and air monitor detected no visible ACM in the excavated area.

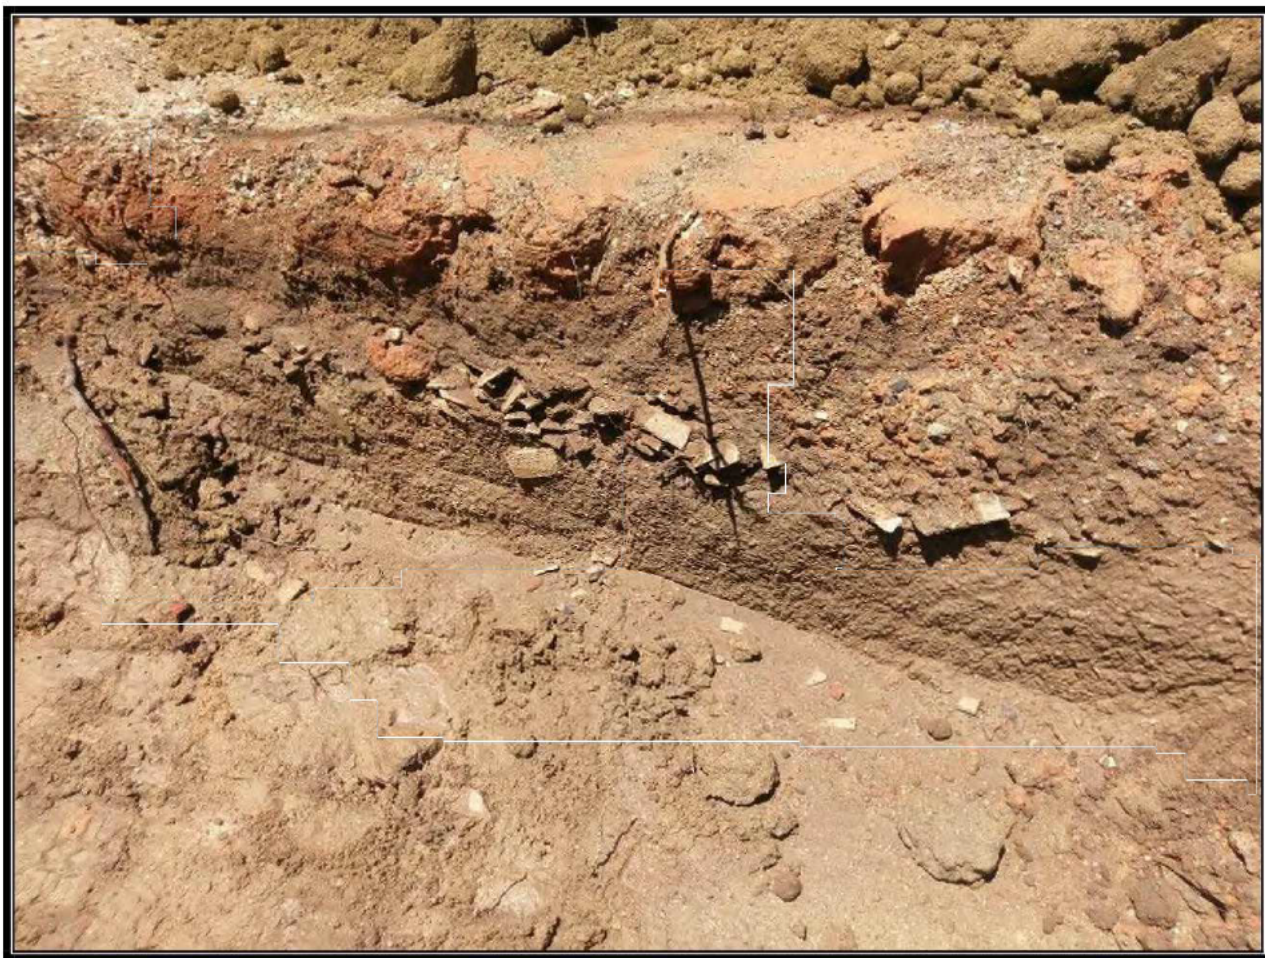
OFFICIAL PHOTOGRAPH NO. 7
U.S. ENVIRONMENTAL PROTECTION AGENCY

Subject: A Tetra Tech START, State of North Carolina-accredited asbestos inspector and air monitor visually inspected the excavated driveway of 315 Sloan Street for the presence of visible ACM. ER removed additional soil in the driveway to a depth of 24 inches, but ACM was visible along the sides of the excavation. Snow fencing was installed on the subsurface and along the sides of the excavated driveway to identify the depth of the excavation and the presence of ACM.

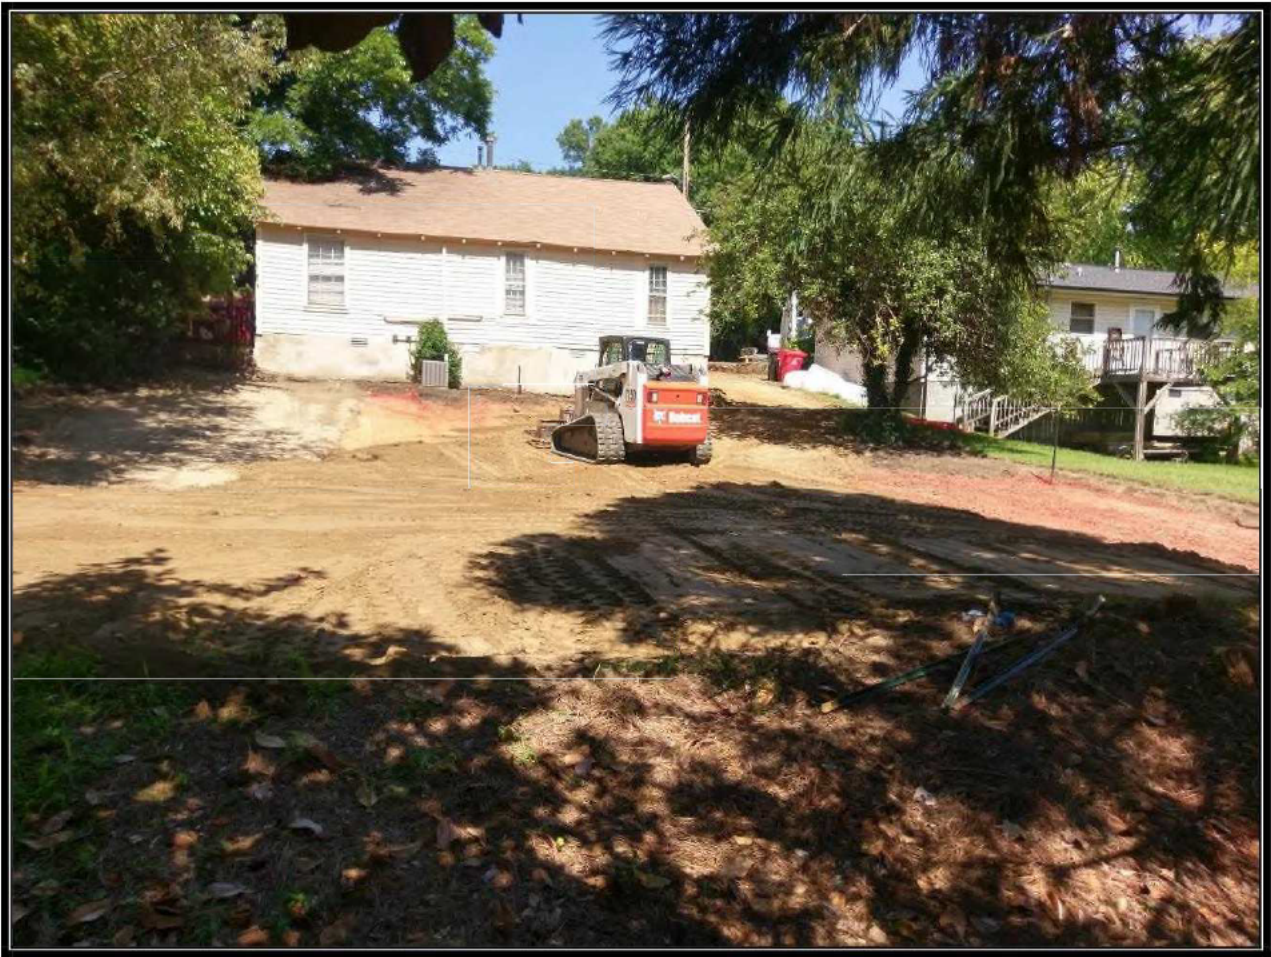
OFFICIAL PHOTOGRAPH NO. 8
U.S. ENVIRONMENTAL PROTECTION AGENCY

Subject: ER used dump trucks and skid steers to install backfill in the excavated areas of 315 and 319 Sloan Street.

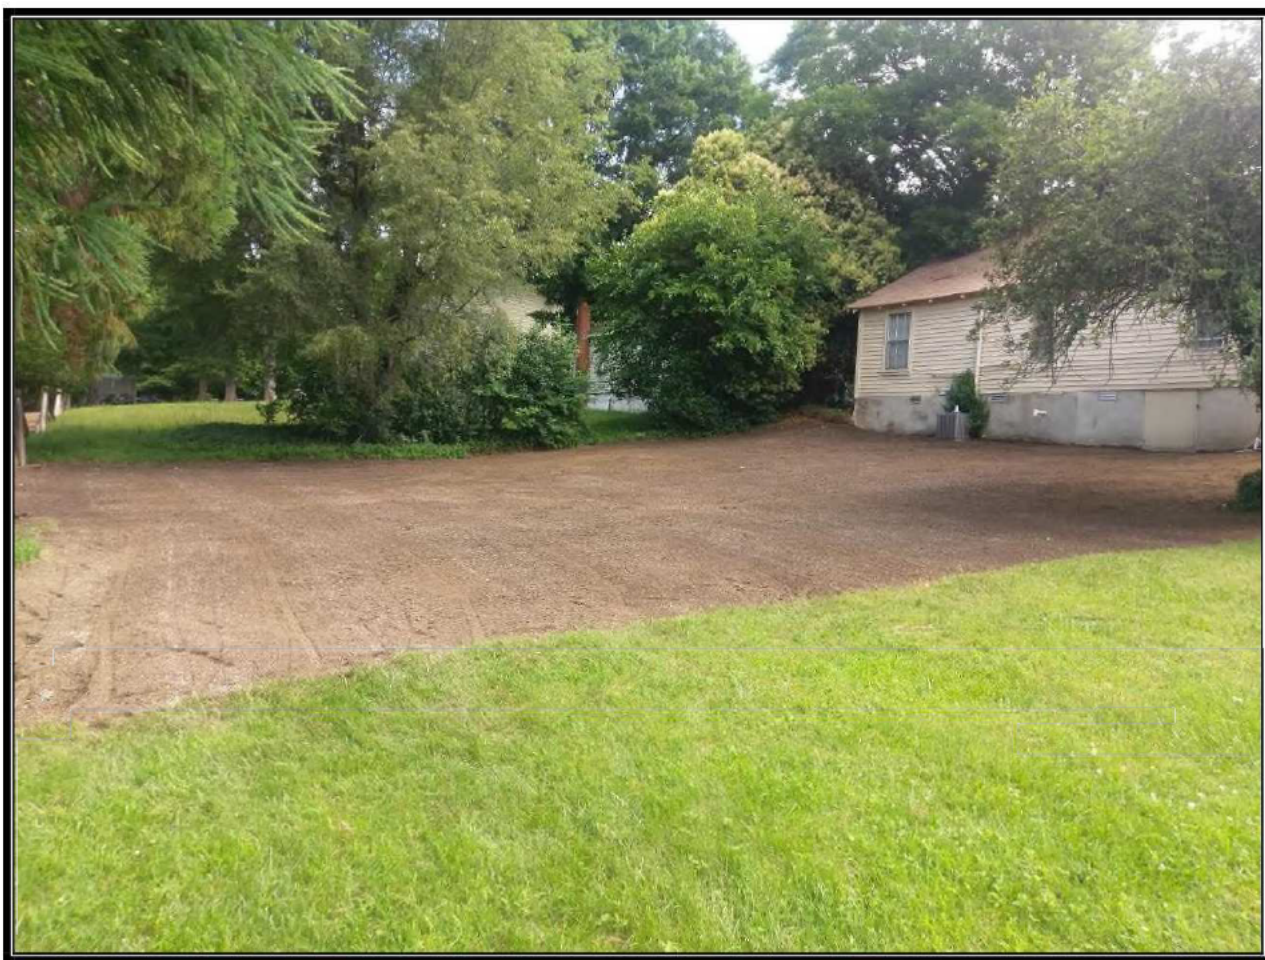
OFFICIAL PHOTOGRAPH NO. 9
U.S. ENVIRONMENTAL PROTECTION AGENCY

Subject: ER used dump trucks, skid steers, and rakes to install topsoil in the excavated back yard of 319 Sloan Street.

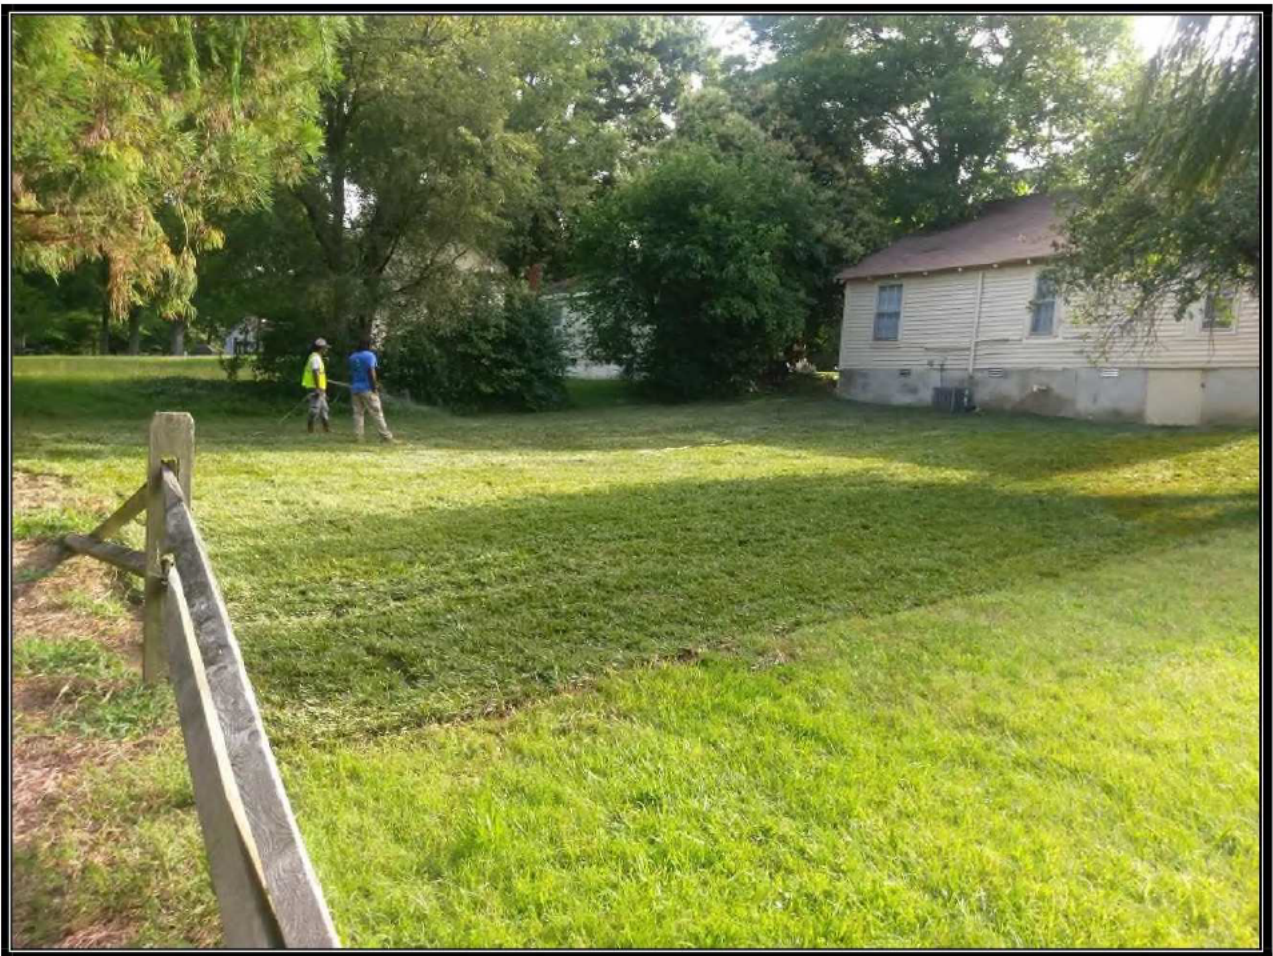
OFFICIAL PHOTOGRAPH NO. 10
U.S. ENVIRONMENTAL PROTECTION AGENCY

TDD Number:	TT-01-071	Location:	Davidson Asbestos
Orientation:	Northeast	Date:	June 16, 2017
Photographer:	Paul Prys, Tetra Tech	Witness:	None
Subject:	ER installed sod in the excavated back yard of 319 Sloan Street after backfill and topsoil were installed.

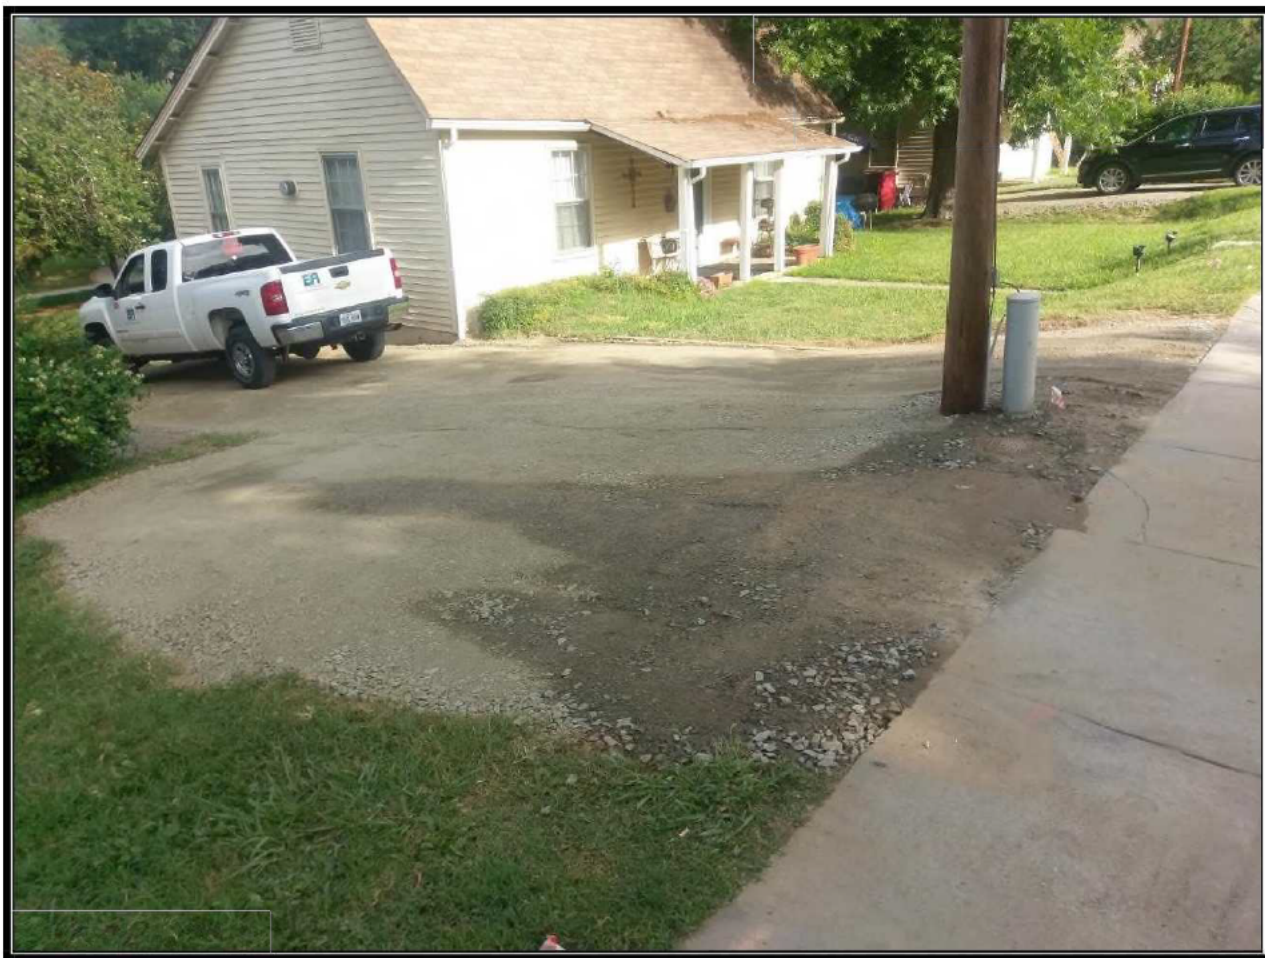
OFFICIAL PHOTOGRAPH NO. 11
U.S. ENVIRONMENTAL PROTECTION AGENCY

Subject: ER installed rock in the excavated driveways at 315 and 319 Sloan Street after backfill was installed.
